Frequently Asked Questions (FAQs)

Following is a list of frequently asked questions (FAQs) covering common problems encountered when operating the WMB-160/80F system. Note the Trouble Shooting section of this manual covers most of the typical operational problems, and this section should be consulted only after reading the Trouble Shooting section. Each FAQ question is numbered and answered in the following pages.

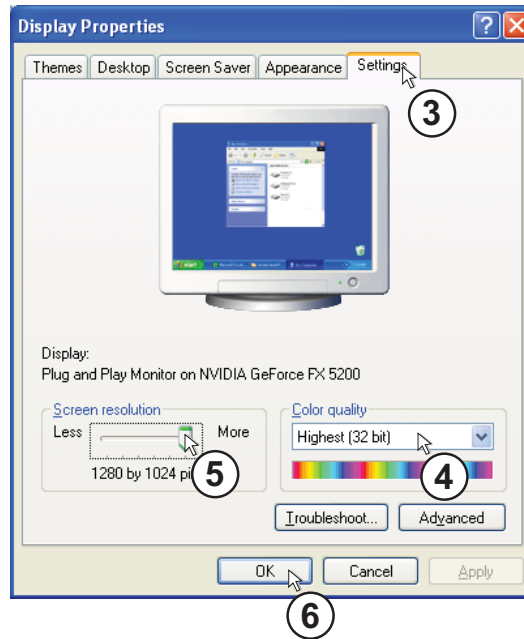
- 3 In the **Display Properties** box, click the **Settings** tab.
- 4 In the **Colour quality** box, set the colour quality to 32-bit.
- 5 On the **Screen resolution** area slider bar, set the resolution to 1024 by 768 pixels.
- 6 Click **OK**.
The new screen settings are applied.

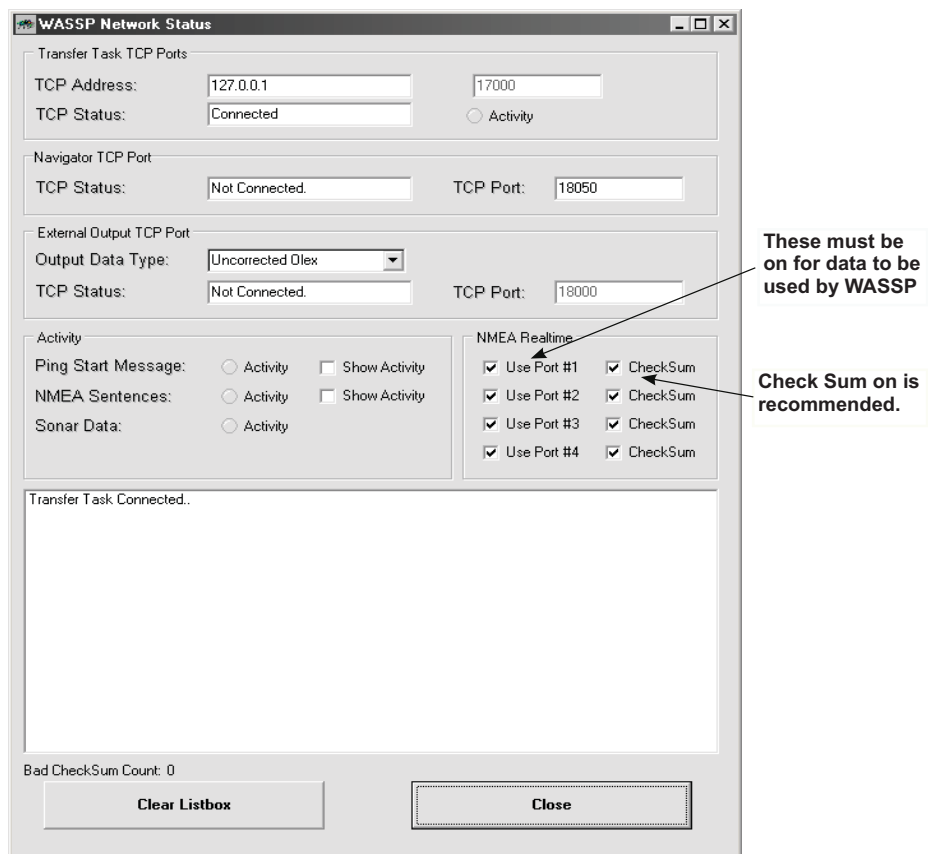
The screenshot shows the 'WASSP Network Status' window with the following settings:

- Transfer Task TCP Ports:** TCP Address: 127.0.0.1, TCP Port: 17000, TCP Status: Connected, Activity:
- Navigator TCP Port:** TCP Status: Not Connected, TCP Port: 18050
- External Output TCP Port:** Output Data Type: Uncorrected Olex, TCP Status: Not Connected, TCP Port: 18000
- Activity:** Ping Start Message: Activity, Show Activity; NMEA Sentences: Activity, Show Activity; Sonar Data: Activity
- NMEA Realtime:**
 - Use Port #1, CheckSum
 - Use Port #2, CheckSum
 - Use Port #3, CheckSum
 - Use Port #4, CheckSum
