## Frequently Asked Questions (FAQs)

Following is a list of frequently asked questions (FAQs) covering common problems encountered when operating the WMB-160/80F system. Note the Trouble Shooting section of this manual covers most of the typical operational problems, and this section should be consulted only after reading the Trouble Shooting section. Each FAQ question is numbered and answered in the following pages.

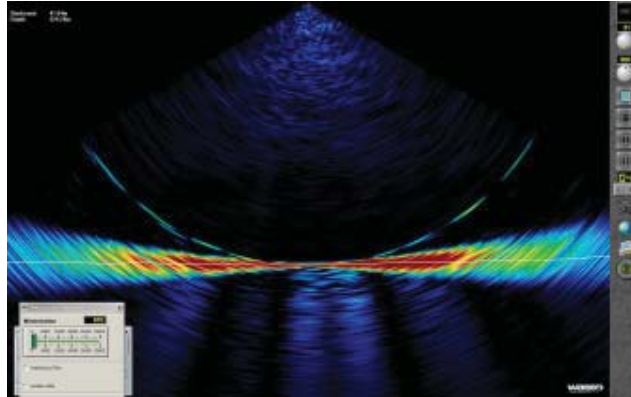
**Question 9 Why is there a ring displayed just above the sea-floor? What causes these 'ring' marks? How can I get rid of them?**

This ring is a by-product of the multi-beam technology of your WASSP system. It is supposed to be there but in practice we want to make it as difficult to see as possible. To avoid these rings confusing the sea floor tracking algorithms or being confused as fish marks the Minimisation feature allows these rings to be suppressed on the Sonar display. Care should be taken because hiding these rings will also make it hard to see any signals below them such as fish on the bottom.

When a signal arrives at the receiver it creates a shadow like effect that creates a ring of much weaker echoes, the stronger the signal the stronger the rings. Unfortunately the signal return from the sea floor is many orders of magnitude stronger than a fish echo and thus the shadow of weaker echoes can be comparable to fish targets.

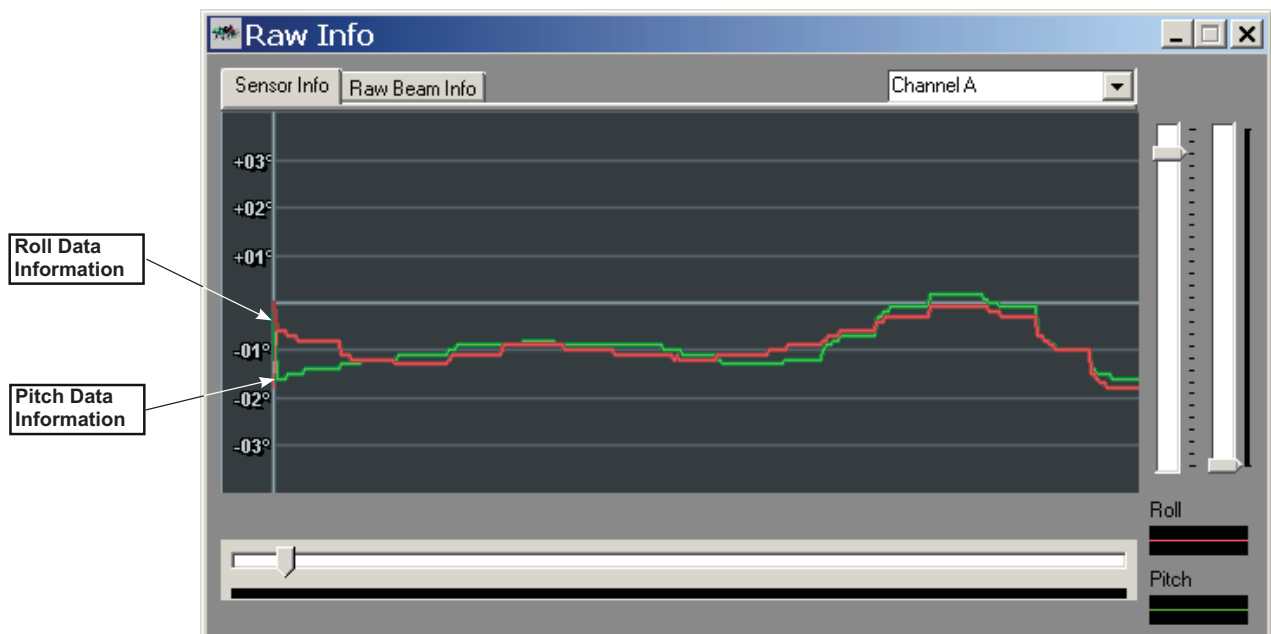
Check Roll Information is being received (Open the Raw Information Form and check the Roll Graph displays roll waveforms). You should see a red line on this display if the Roll information is being processed.

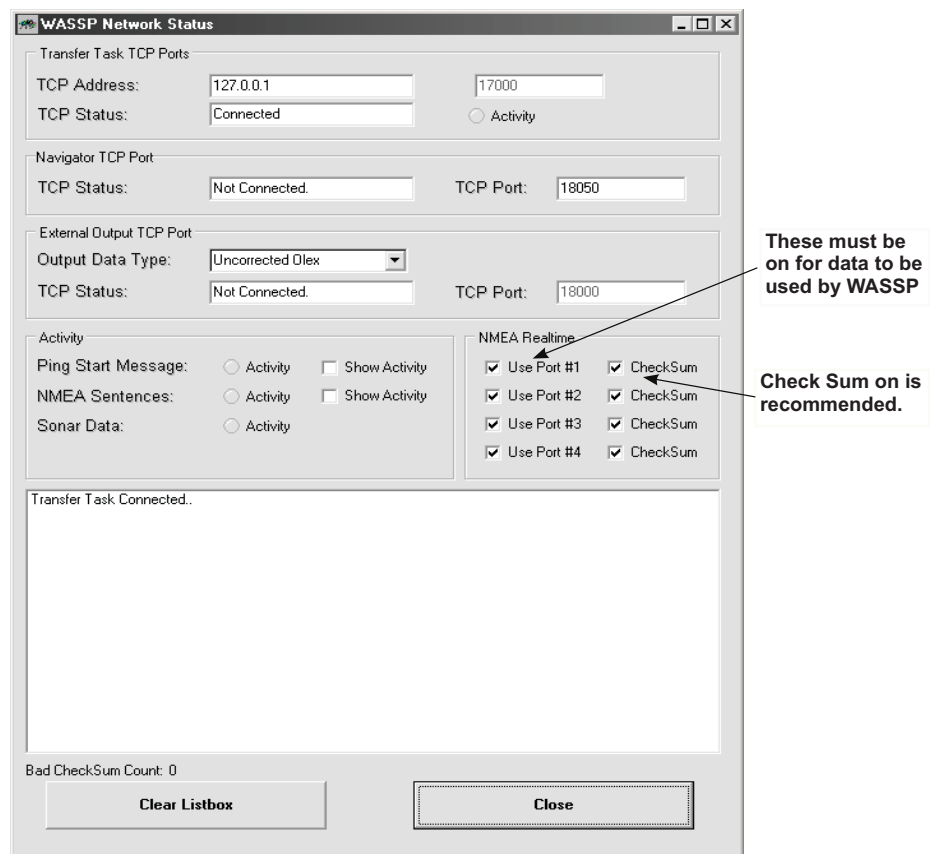
The screenshot shows the 'WASSP Network Status' window with the following settings:

- Transfer Task TCP Ports:** TCP Address: 127.0.0.1, TCP Port: 17000, TCP Status: Connected, Activity:
- Navigator TCP Port:** TCP Status: Not Connected, TCP Port: 18050
- External Output TCP Port:** Output Data Type: Uncorrected Olex, TCP Status: Not Connected, TCP Port: 18000
- Activity:** Ping Start Message:  Activity,  Show Activity; NMEA Sentences:  Activity,  Show Activity; Sonar Data:  Activity
- NMEA Realtime:**
  - Use Port #1,  CheckSum
  - Use Port #2,  CheckSum
  - Use Port #3,  CheckSum
  - Use Port #4,  CheckSum
