## 7. Frequently Asked Questions (FAQs)

Following is a list of frequently asked questions (FAQs) covering common problems encountered when operating the WASSP System system. Note the Trouble Shooting section of this manual covers most of the typical operational problems, and this section should be consulted only after reading the Trouble Shooting section. Each FAQ question is numbered and answered in the following pages.

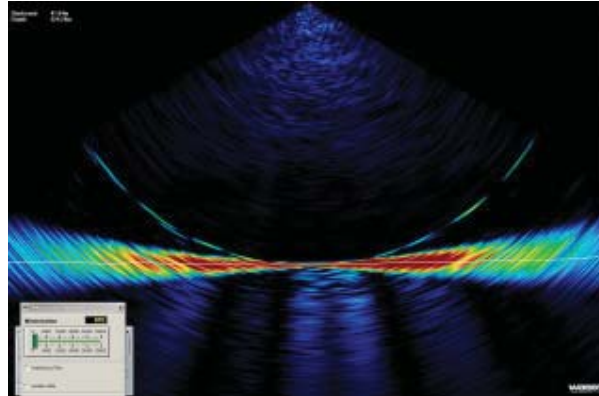
This ring is a by-product of the multibeam technology of your WASSP system. It is supposed to be there but in practice we want to make it as difficult to see as possible. To avoid these rings confusing the seafloor tracking algorithms or being confused as fish marks the Minimisation feature allows these rings to be suppressed on the Sonar display. Care should be taken because hiding these rings will also make it hard to see any signals below them such as fish on the bottom.

When a signal arrives at the receiver it creates a shadow like effect that creates a ring of much weaker echoes, the stronger the signal the stronger the rings. Unfortunately the signal return from the seafloor is many orders of magnitude stronger than a fish echo and thus the shadow of weaker echoes can be comparable to fish targets.

How do I know if I have a problem then? When running with Auto Power By Signal (BLUE) and the power level is above 1 then the required minimisation should be 1500 or less. The lower this is the more chance of seeing fish below the ring but the more chance of the rings being visible on the Sonar display. If you are required to use a higher power level then it may well be impossible to hide them completely with Minimisation.

- a) Too much power – This is the most common cause of problems. When there is too much acoustic energy in signals returned from the seafloor they may distort. Distortion of the signals will cause ambiguity in resolving the position and thus create rings of very high amplitude. Unless in very shallow water Auto power by Signal mode will automatically try to select the highest power level that doesn't cause distortion. You may get the occasional strong return causing faint rings, but this is good so that you have as much power as practical for detecting fish.

- b) Gain settings. This ring will appear more or less significant as the sonar gain is changed.
- c) Shading of Receiver – Any difference across the receiver caused by marine growth or any other irregularity across the face of the receiver will contribute to a reduction in the discrimination of the WASSP system. This will lead to higher intensity rings.

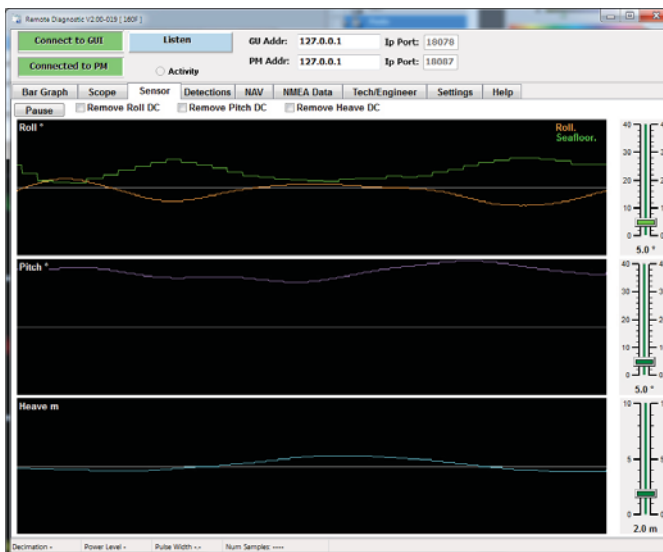
Finally if the seafloor is not uniformly flat you could see rapid changes in the sonar display with each ping as the ship moves across the sea floor. As there is no heave or pitch compensation on this display it will often move up and down and if the seafloor changes angle it will also appear to roll a bit. If you are unsure check that the seafloor remains flat on a flat piece of seafloor and remember that a vertical shift is expected if there is vessel roll, pitch and or heave. These artefacts should be mostly removed when you look at the WASSP Contour display which is corrected for the measured attitude elements.

- ▶ Check that the Roll Configuration settings have not been changed. If the transducer array has been re-installed, the Swap Array setting could have changed in which case you will need to invert the Roll Configuration. When in doubt, use the values that were recorded in the Installation Manual at time of commissioning. If the roll offset is incorrect a slight roll of the display will occur. If the roll polarity is incorrect you will see a doubling of the actual vessel roll (i.e. compared with having the roll compensation disabled).
